# Fire Risk Assessment

Prepared for  
**The Rodillian Academy Trust**

**Location**  
**Featherstone Academy**  
**Pontefract Road**  
**Featherstone**  
**Pontefract**  
**West Yorkshire**  
**WF7 5AJ**

**Date**  
**20<sup>th</sup> April 2016 (ver. 1)**

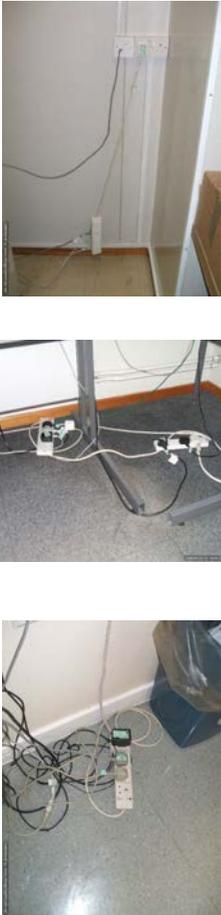
Portable electrical equipment / Use of adapters	There is extensive use of multi-socket adapters in the premises. Whilst some were clearly within load limits, others were at risk of overload, were	L	Medium	-

Item Description	Action Required	L/R	Priority Rating	Freq	Photograph	Progress / Completion Notes
	<p>daisy chained together, used with other adapters, or were installed in such a way to strain or damage internal cables.</p> <p>A full detailed survey should be carried out by a competent person to assess the use of adapters and the availability of ring main wall sockets and prioritise the provision of additional wall socket capacity dependant on the overload/damage risk of a particular set up.</p> <p>In providing additional sockets the capacity and condition of the ring main circuits and their cabling must be taken into account to avoid moving the risk from the portable appliances, cabling and adapters to the foixed wiring in the wall &amp; ceiling voids</p>

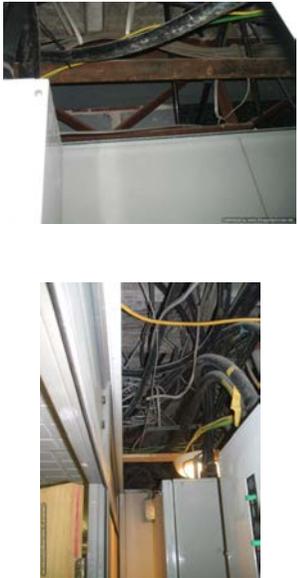
Item Description	Action Required	L/R	Priority Rating	Freq	Photograph	Progress / Completion Notes
Ceiling Tiles / Ceiling tiles	Ensure all ceiling tiles are replaced / repaired to assist effectiveness of smoke detectors and to prevent accelerated spread of fire and combustion products through the voids	L	Medium	-		
Fire Stopping / Fire stopping	Fire-stopping is limited to the premises and should be gradually upgraded with the introduction of cavity barriers to subdivide rooms of from corridors and enclose stairways and rooms of high risk where not already present and in good order.	R	-	-

Item Description	Action Required	L/R	Priority Rating	Freq	Photograph	Progress / Completion Notes
	<p>Cable and service penetrations should be likewise sealed.</p> <p>(It is appreciated that this is difficult to achieve in some areas due to existing service runs, asbestos and access issues and that the fire detection system is a mitigating factor)</p>
